**NATIONAL TRANSPORTATION SAFETY BOARD**

**Group Chairmen's Factual Report**

**OPERATIONAL FACTORS/ HUMAN PERFORMANCE**

**CEN19FA072**

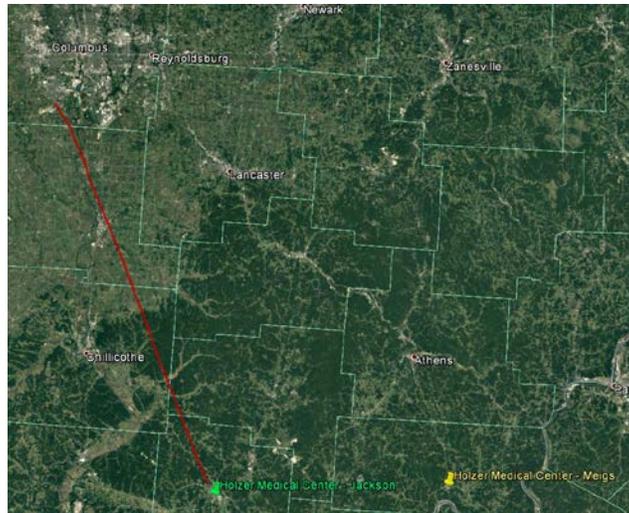
Figure 3. Flight track of accident pilot’s flight to Holzer Jackson Hospital on January 24, 2019.

The accident flight was the pilot’s first trip to Holzer Meigs Hospital, located about 70 nm southeast of Columbus. Since October 2018, the pilot had flown twice to a destination about 30 nm to the west of Holzer Meigs Hospital, Holzer Jackson Hospital: November 12 and January 24. The flight on January 24, 5 days prior to the accident, was between Grove City, Holzer Jackson Hospital, and Ohio State University in night VMC conditions. The accident destination required a more southeasterly route compared to Holzer Jackson Hospital and was flown about an altitude of 1500 ft msl, 500 feet above ground level.<sup>15</sup>

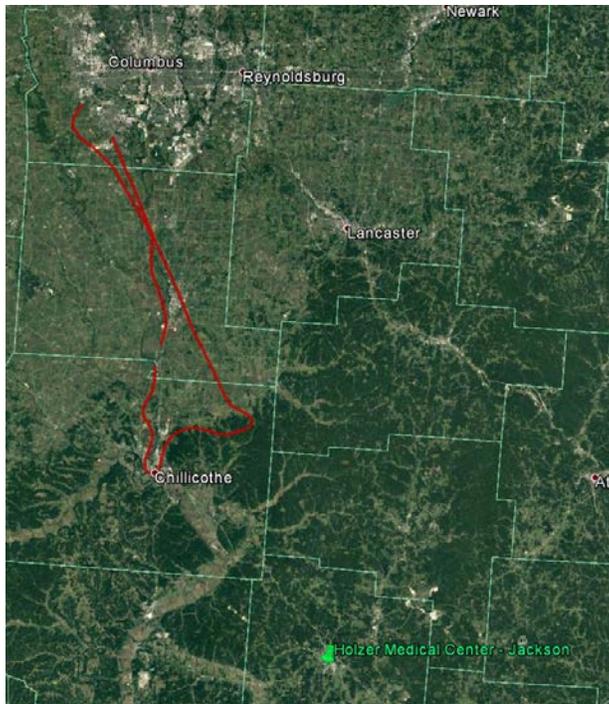
Figure 4. Flight track of base 14 lead pilot flight on December 6, 2018.

- December 6, 2018 “Wx enroute reporting VFR, Ran into falling snow at Ross Co Line upon reaching Hill terrain east of Chillicothe, reached out to OCC, turned west to attempt to go around and ran into haze with precipitation (mild) 4 sm vis. Aborted, headed to Bolton for fuel.”
- January 10, 2019: “Mild snow squall, vis greater than 4 miles, 25 mi N of hospital”
- January 10, 2019: “Snow avoidance in flight, vis 4 mile”
- January 15, 2019: “Visibility dropped in flight. Less than 3 SM. Rime ice formation on bottom of windscreen along window molding. Aborted returned to base. Conditions NOT as reported.”

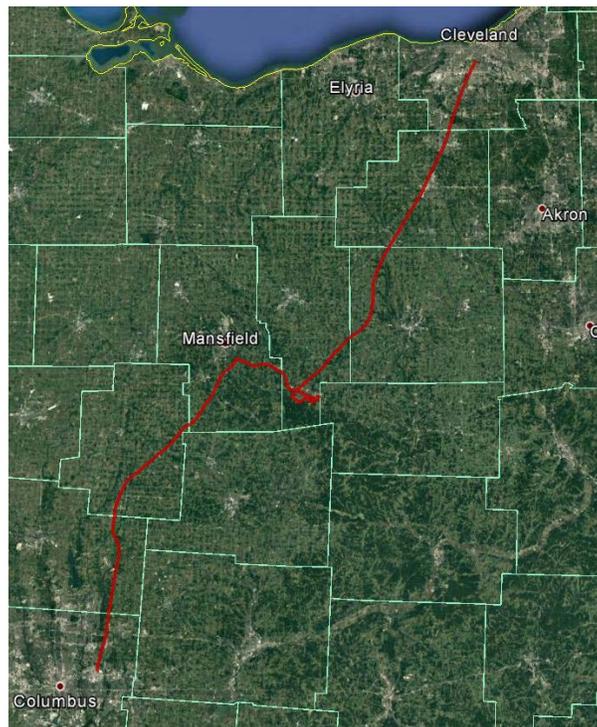
Figure 6. Flight track of base 14 lead pilot flight on January 14, 2019.

- Flight A4: During a flight from Cleveland to Columbus, the flight encountered heavy fog and reduced visibility. During preflight, the pilot had noted that there was an area reporting below weather minimums between Cleveland and Columbus. The medical crew voiced concerns about low visibility during the flight. The paramedic stated that they “became engulfed in it ... it was a complete whiteout. We lost sight of the ground. We lost sight of everything.” The pilot verbalized that he was beginning a standard rate turn and they exited IMC conditions about a minute later. After approaching a town that was in VMC conditions, the crew began brainstorming where they could land the helicopter to wait out the weather. Instead of landing, the pilot elected to use Mansfield airport tower to guide them to the highway. The paramedic stated that “...once we left ... the town -- -- then we went straight back into marginal conditions...” After intercepting Interstate 71, they flew south along the highway towards Columbus. Upon hearing that another aircraft reported clear conditions at 1000 feet, the paramedic said that they “essentially left from following the middle of the highway, ..., being able to see the highway. We rose through the clouds until we lost visibility with the ground” According to the paramedic, the flight descended back down to follow the highway. They then landed at CMH for fuel.

Upon review of the shift briefing/debriefing paperwork and flight track, a flight conducted on January 14, 2019 was consistent with the description in this incident.<sup>22</sup> The flight track and altitude above ground level is presented below:
